**NPDES
INSPECTION REPORT**

**WASTEWATER TREATMENT FACILITY
PARMA, IDAHO**

**INSPECTION DATE: June 6, 2012
REPORT DATE: June 20, 2012**

**Prepared By:
Michael Spomer
Technical Services
Idaho Department of Environmental Quality**

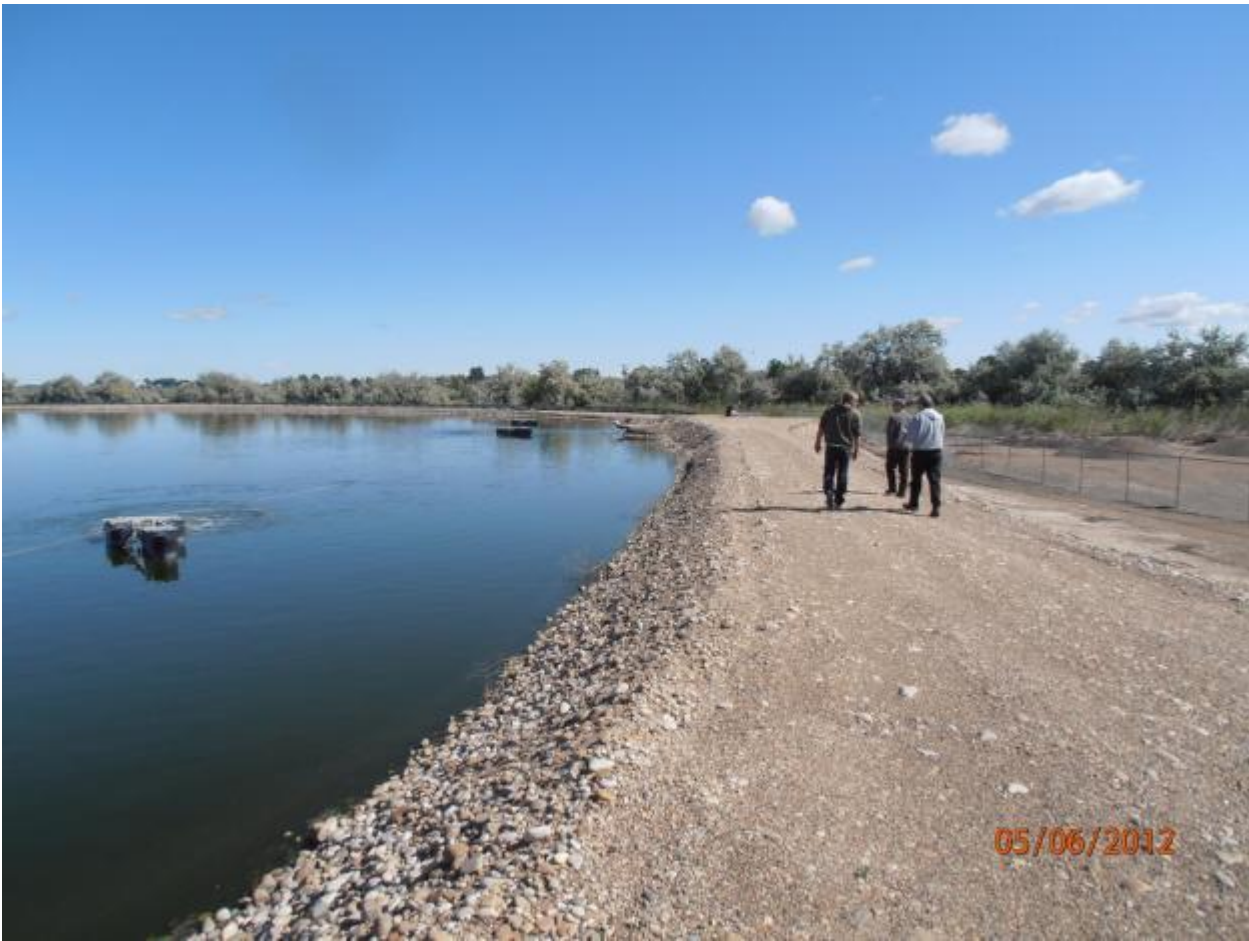
Photograph 3. East dike of Lagoon #1 looking towards influent discharge pipe.

Facing north northeast along Lagoon #1 eastern dike towards the lift station discharge.
Notice the elbow is turned upwards to maintain elevation in the wet well.

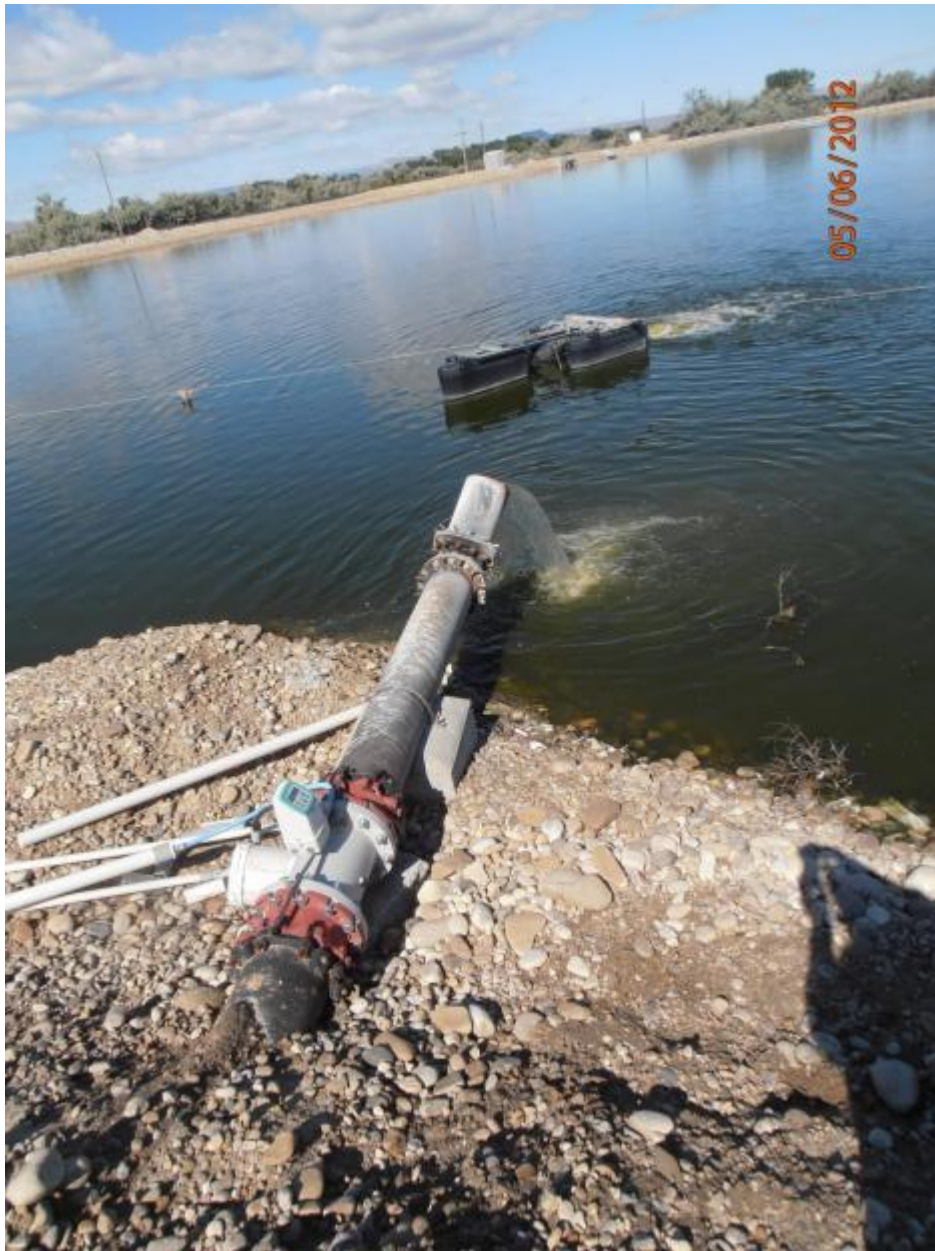
Photograph 6. Influent discharge pipe to Lagoon #1.

Influent discharge pipe. Upturned elbow maintains full pipe flow for proper flow meter operation.

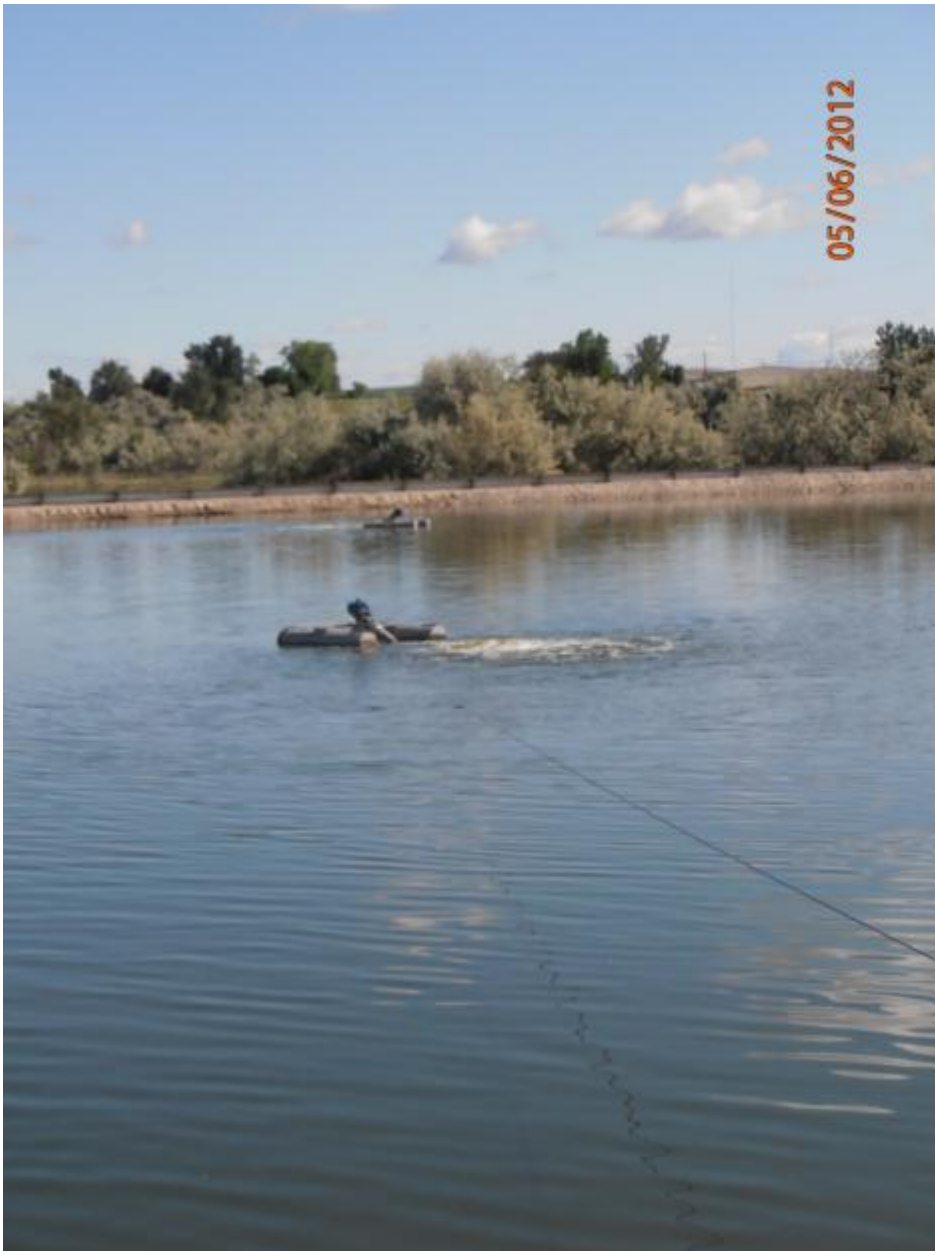
Photograph 16. Lagoon #1 aerators at far west end of lagoon.

Facing north northeast at the final 2 of 5 aerators in Lagoon #1. System only requires 4 aerators, but they have 5 providing 1 aerator as backup.

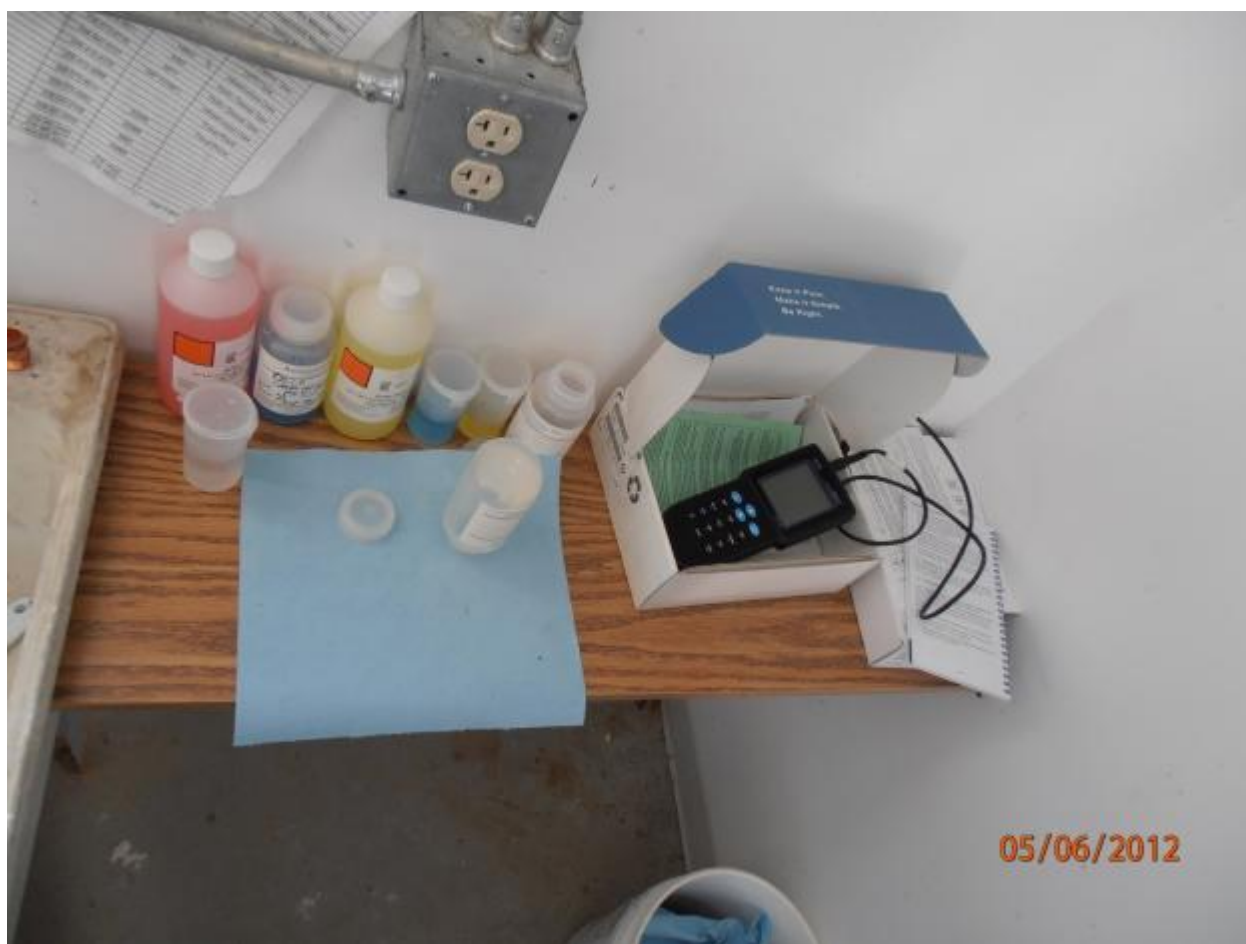
Photograph 37. pH meter and pH calibration solutions.

3. During the field inspection of the on-site lab testing equipment located in the Chlorination Building, the Lab SOP Manual contained the procedure for calibration of the old pH meter. The SOP had not been updated to include the calibration procedure for new pH meter currently being used by the City. Section I D. 2. states: “the permittee must use the EPA-approved QA/QC and chain of custody procedures.”

pH meter also monitors salinity/conductivity. Located in Chlorination Building's southeast corner.

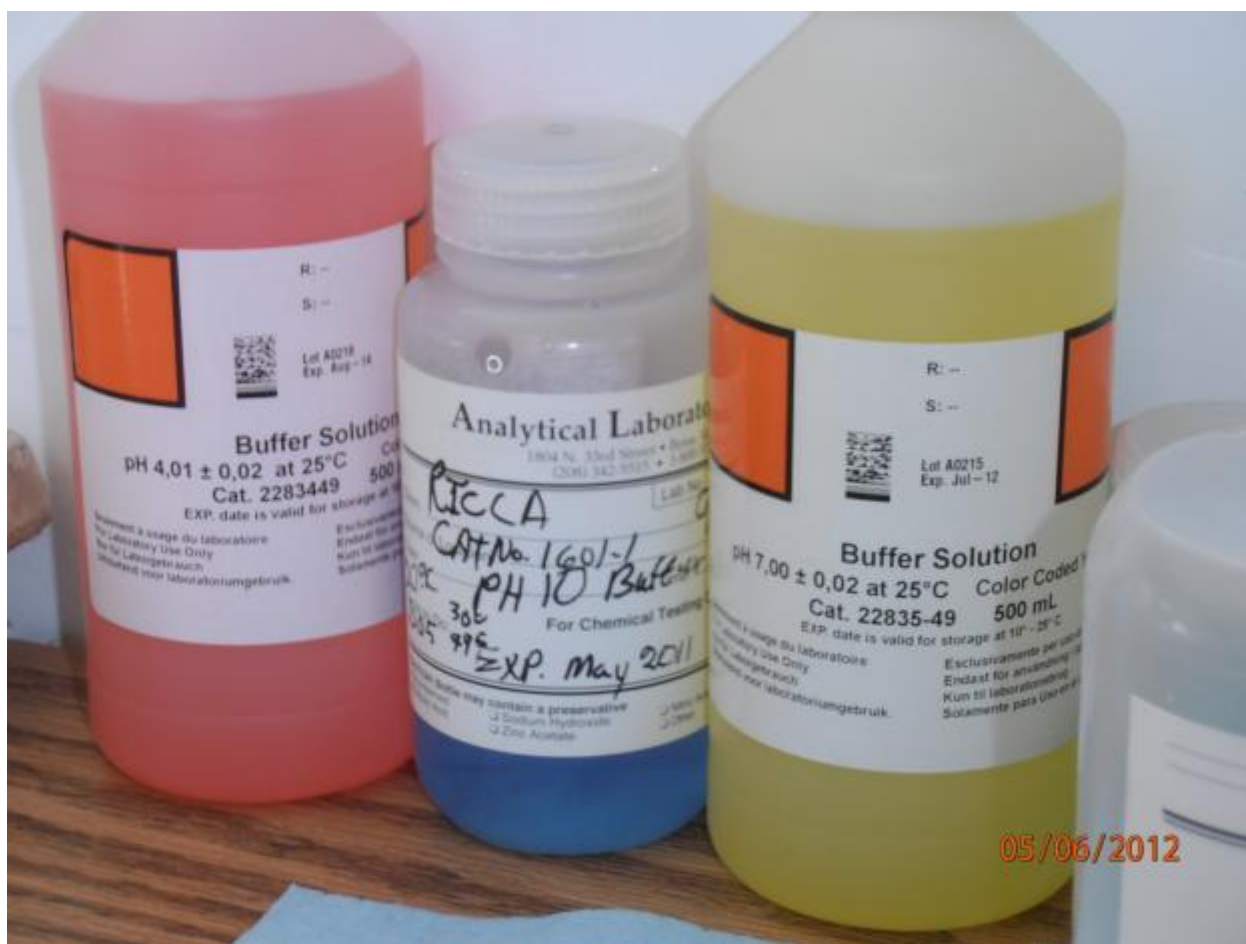
Photograph 38. pH buffer solutions.

2. During the field inspection of the on-site lab testing equipment located in the Chlorination Building, the pH 7 buffer reagent used by the City to calibrate the pH meter had an expiration date of May 2011. Section I D. 2. states: “the permittee must use the EPA-approved QA/QC and chain of custody procedures.” **My concern is that the May 2011 through May 2012 Monthly DMR may not be true, accurate, and complete.**

Acidic buffer solution expiration date is August 2014, neutral buffer solution is expired in May 2011, and basic buffer solution expiration date is July 2012.

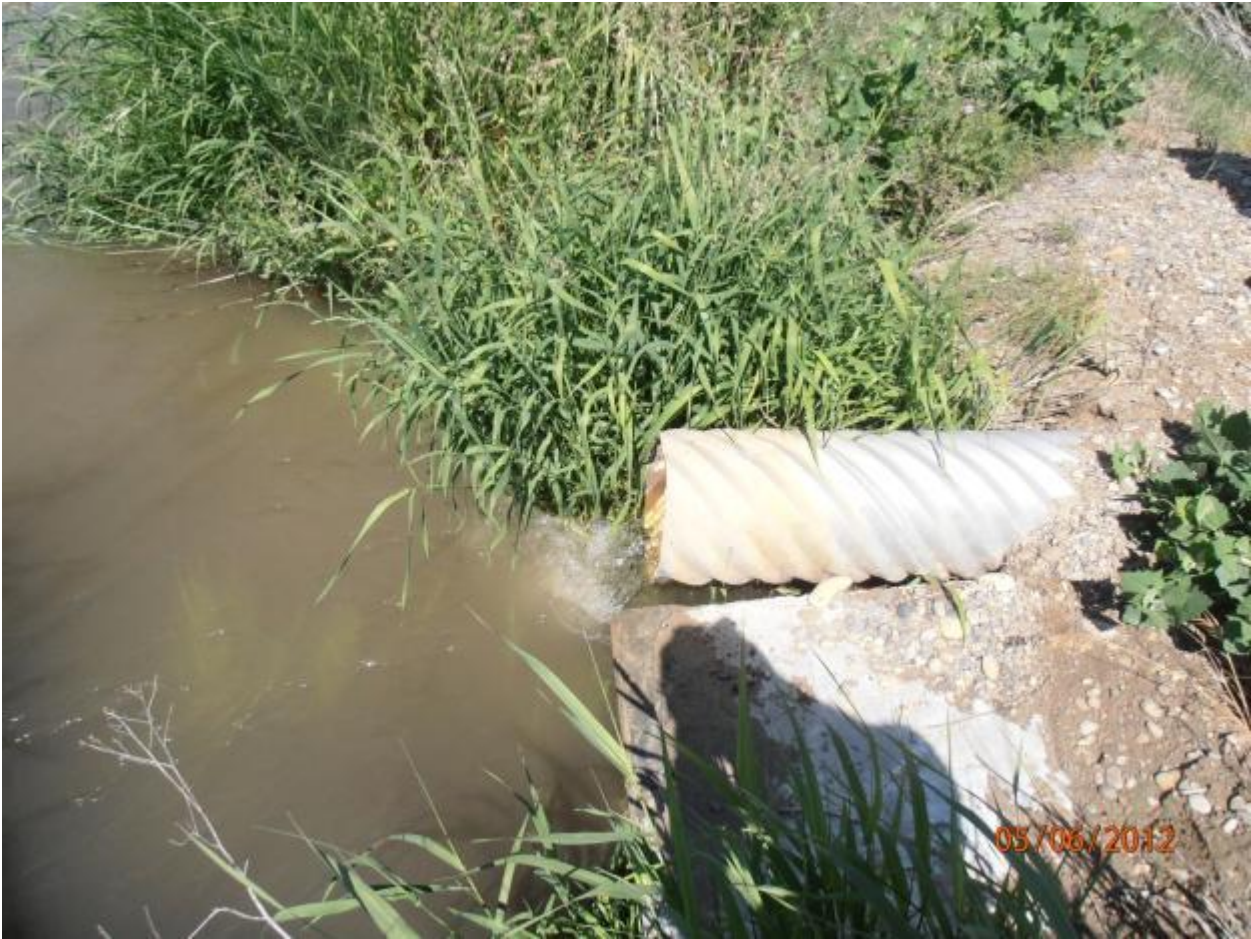
Photograph 43. Discharge pipe and effluent discharge sample collection point.

Samples typically collected here except during high flow seasons.
Collection during high flows are made at manhole access about 75 feet north of this point.

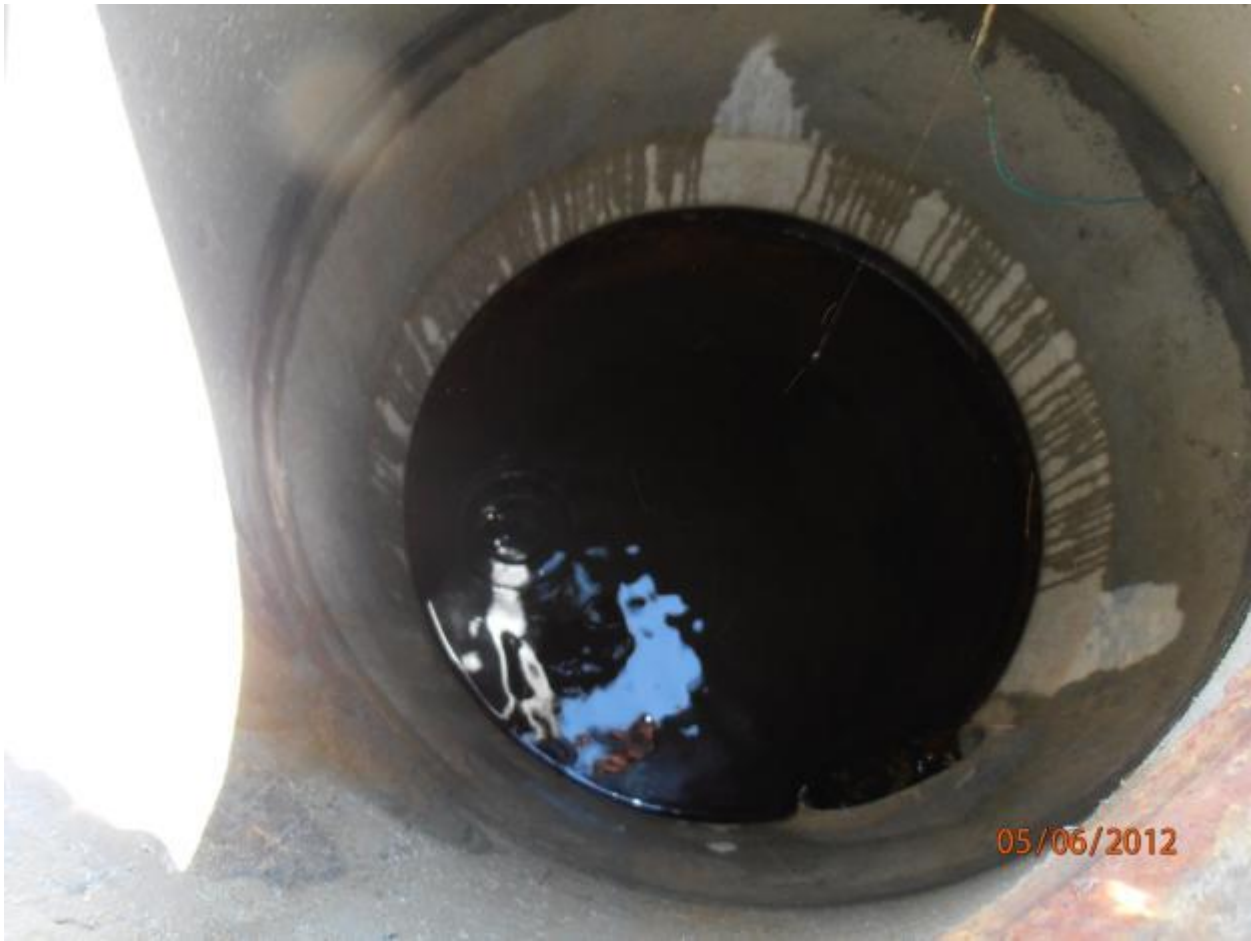
Photograph 44. Manhole immediately preceding discharge point.

Discharge samples collected here when discharge pipe is inundated by Sandhollow Creek.

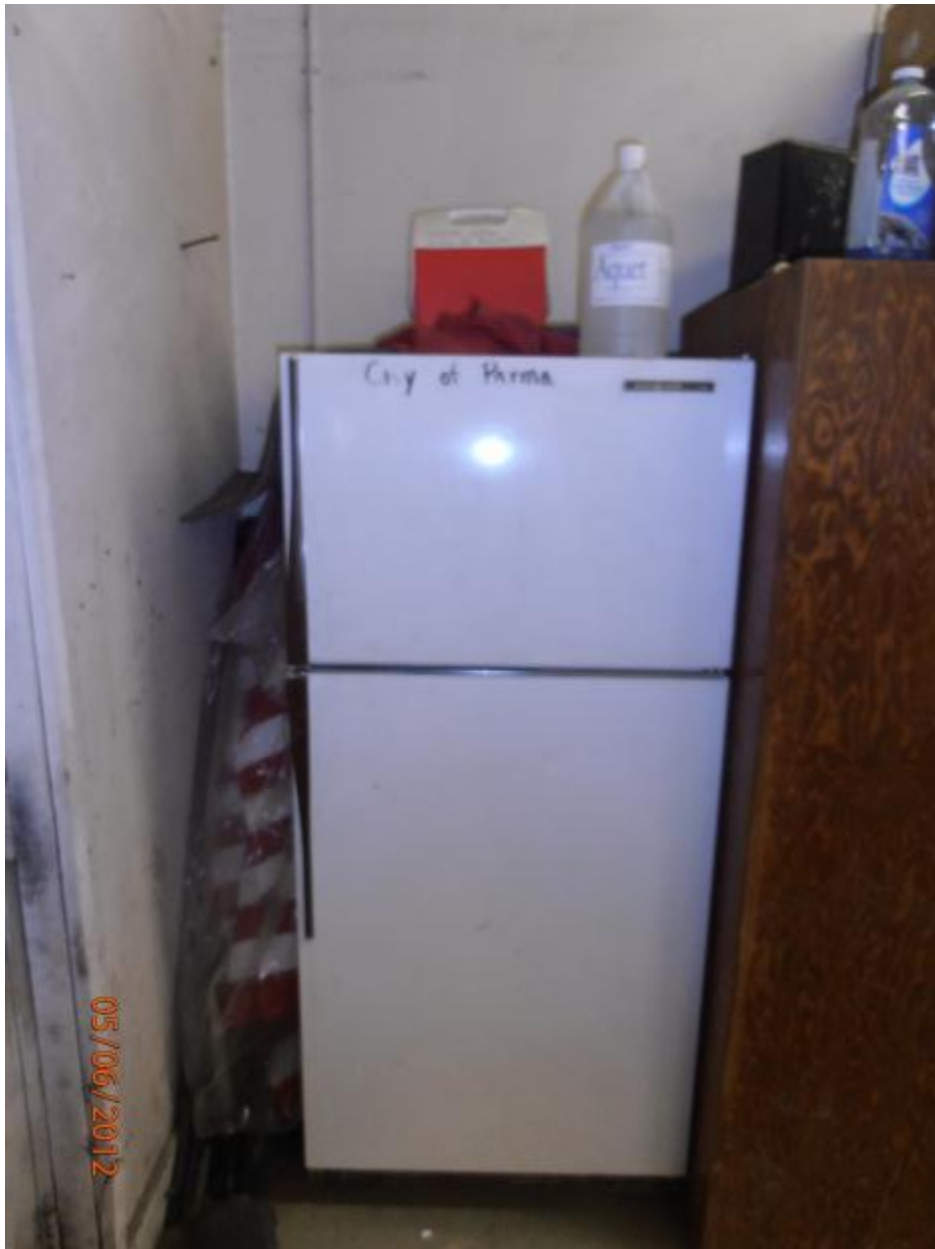
Photograph 51. Sample storage refrigerator with wastewater sample cooler on top.

5. During the review of the sample collection performed by the City, the wastewater samples are held in a refrigerator, located in the shop, prior to being sent for analysis. The refrigerator was not equipped with a temperature measuring device to determine the samples are cooled to at least 6° C. Failure to properly control the temperature of the

collected samples could result in invalid lab analysis. Section I D. 2. states: "the permittee must use the EPA-approved QA/QC and chain of custody procedures." **My concern is that at the least, the May 2012 Monthly DMR may not be true, accurate, and complete.**

Refrigerator is located in the back of the City Shop Building. The refrigerator does not have a thermometer in it.

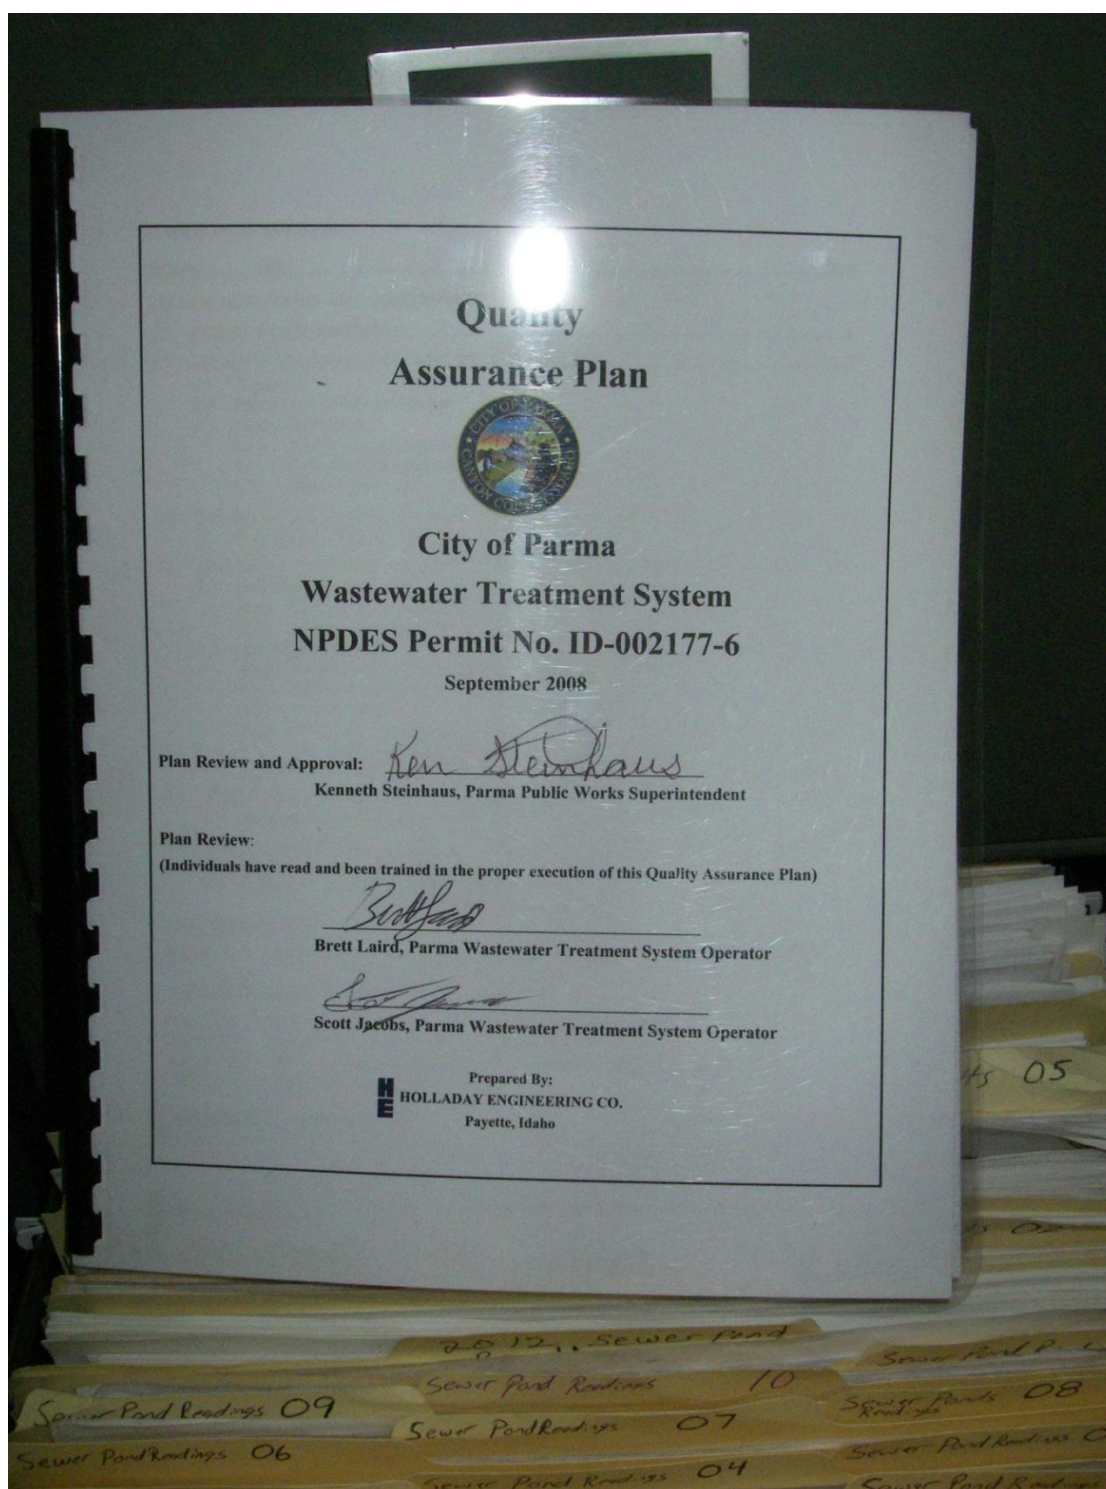
Part I Section D of the permit states: “the permittee must develop a Quality Assurance Plan for all monitoring required by the permit.” The plan must be developed and implemented by November 1, 2004. During the inspection, the only available copy of a QAP was found in the Chlorination Building at the treatment site. The copy available was dated September 2008, was watermarked as a draft, and was not signed or approved by anyone. In addition, Part I Section D.5. states: “Copies of the QAP must be kept on site.” Mr. Steinhaus contacted DEQ the following week informing the inspectors that he had located the signed copy of the QAP. A.J. Maupin, P.E., revisited the city office and the Chlorination Building on June 21, 2012 to verify that official QAPs were resident in these city locations. **My concern is that the City of Parma was not able to produce a true, accurate, and complete Quality Assurance Plan, as required under Part I Section D of the permit at the time of the inspection.**

Photograph 56. QAP, dated September 2008, in Office filing cabinet. Picture taken on 21 June 2012 during follow up visit after Parma notified DEQ inspectors that they had found the official QAP.

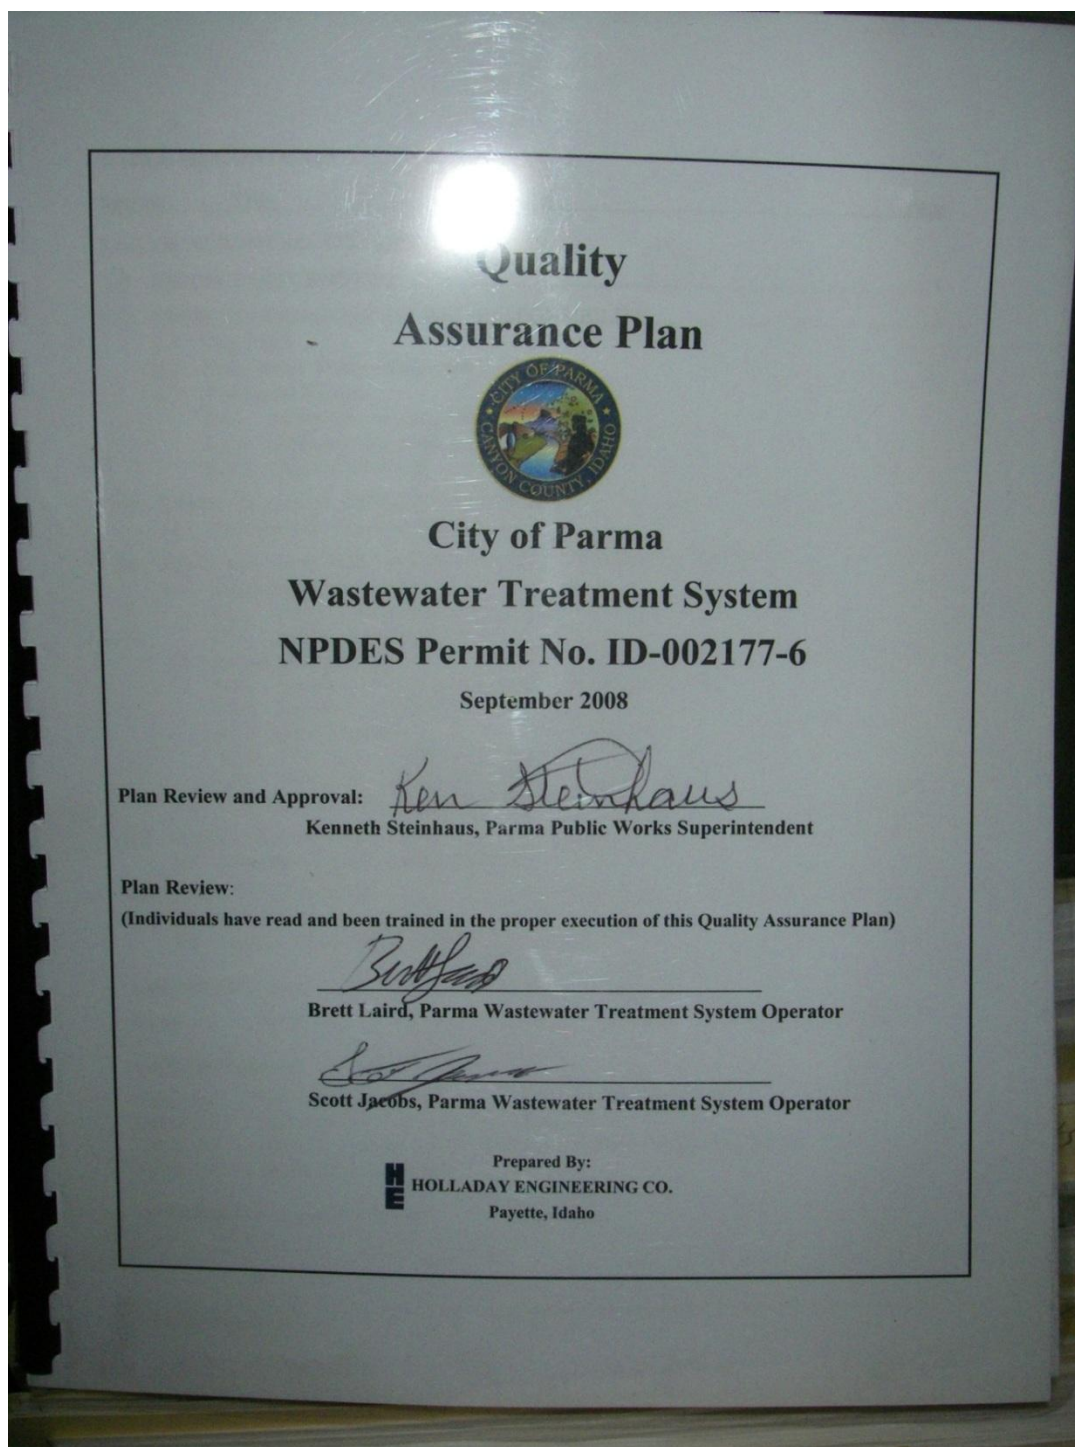
Photograph 57. Close up of QAP, taken 21 June 2012, in office filing cabinet.

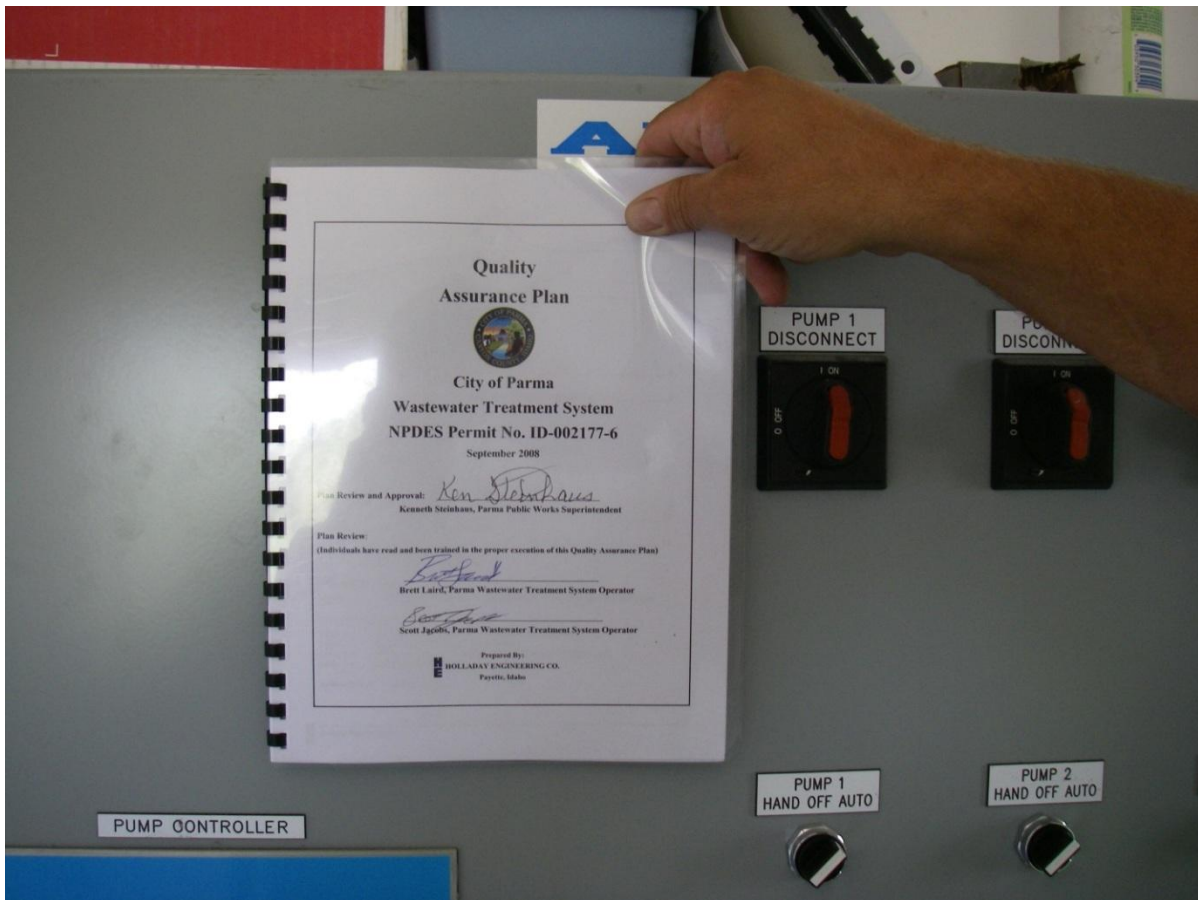
Photograph 58. Photograph of QAP copy kept in Chlorine Building lab room out at the wastewater treatment lagoons, taken on 21 June 2012.
